EXECUTIVE SUMMARY

Ridgeland Common is a 6.06 acre heavily used park and recreation site. It contains a 35,000 square foot main building built in 1962 that includes a 27,000 square foot ice rink/indoor soccer field. It also features a 50-meter outdoor pool, two lighted ball fields, a sled hill and a recently provided dog friendly area. Ridgeland Common serves many

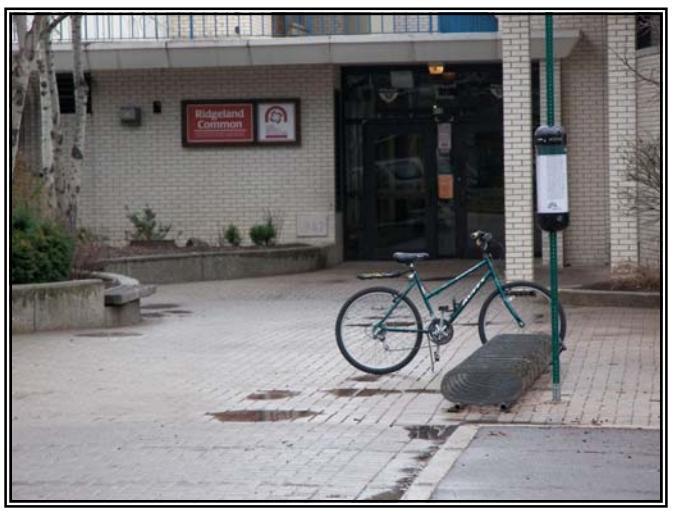
Despite the fact that Ridgeland Common has become physically and functionally obsolete, it continues to provide a home to many popular events and programs for Oak Park residents.

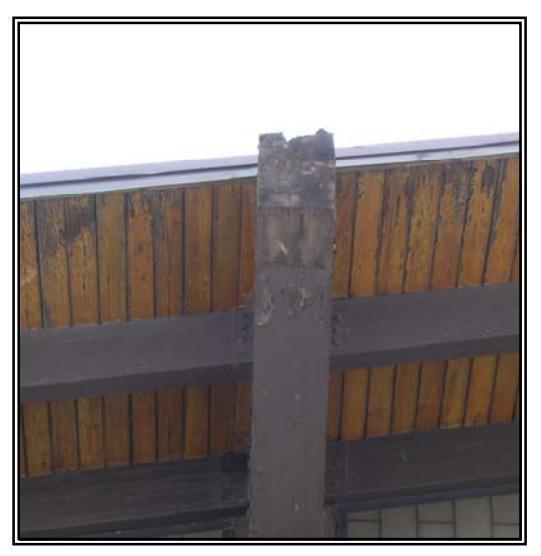
A deteriorated beam end, identified in the architectural assessment, illustrates the need for substantial repairs at Ridgeland Common.

aquatic systems and a park site analysis. The Team concluded that extensive renovation of most of Ridgeland Common is needed within a 5-year time span. The Team also determined that the Park District carefully should consider the substantial costs of renovating existing improvements versus building a new facility. The Team found that even if it is renovated/repaired, Ridgeland Common's facilities are functionally obsolete. Ridgeland Common no longer represents the "flagship" facility it formerly did and lacks the flexibility to meet new programming needs. The total cost of the renovations/repairs recommended is

estimated between \$9.01 Million and \$9.73 Million in 2007 dollars.

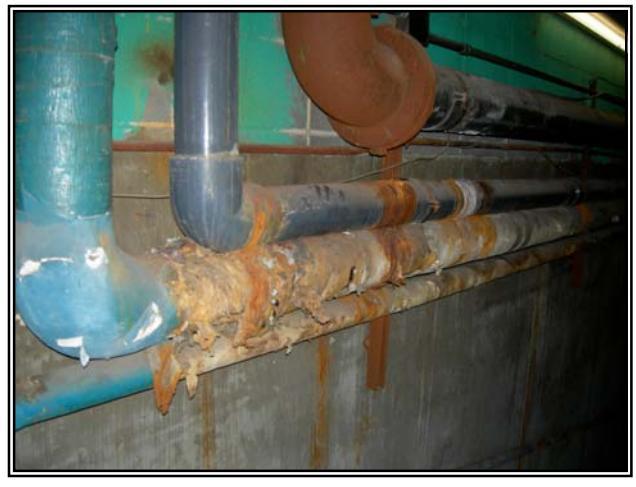
Building systems in disrepair are a common sight at Ridgeland Common and cause many day to day maintenance issues. Unfortunately, undertaking extensive renovation/repair is costly and time consuming.
